THE CALIFORNIA EARTHQUAKE OF APRIL 18, 1906

REPORT

STATE EARTHQUAKE INVESTIGATION COMMISSION

VOLUME I, PART I

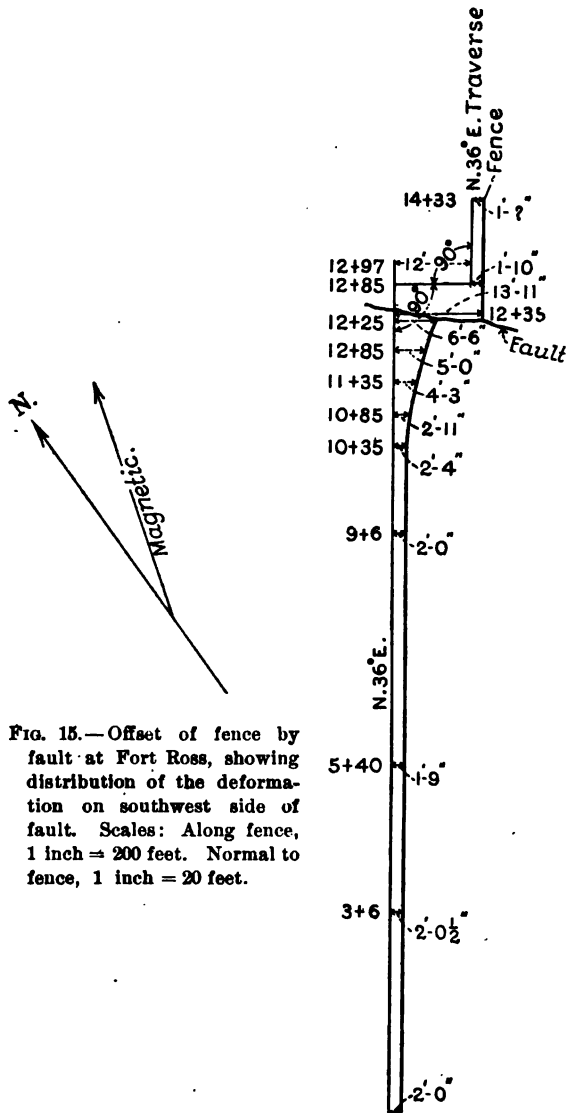
FIG. 15.—Offset of fence by fault at Fort Ross, showing distribution of the deformation on southwest side of fault. Scales: Along fence, 1 inch = 200 feet. Normal to fence, 1 inch = 20 feet.

results of his survey are shown in fig. 15. The bearing of the fence is N. 36° E. He reports that for the first 1,000 feet from the southwest end of the fence the greatest error in alinement was about 1 inch, and that practically there was no deformation in this stretch. In the next 125 feet going northeast there was found a deviation from this alinement of 4 inches to the southeast. In the next 50 feet the deviation in the same direction was 7 inches more. In the next 140 feet the deviation in the same direction was 3 feet 7 inches more. Then came the fault-trace with an abrupt displacement of the fence of 7 feet 5.1 inches. Northeast of the fault-trace the fence retained its line very well. In 100 feet it was out only 1 inch. Beyond this it enters the timber and its course is somewhat influenced by the larger trees, but maintains its line within a few inches. These measurements give a total horizontal displacement of 12 feet distrib-

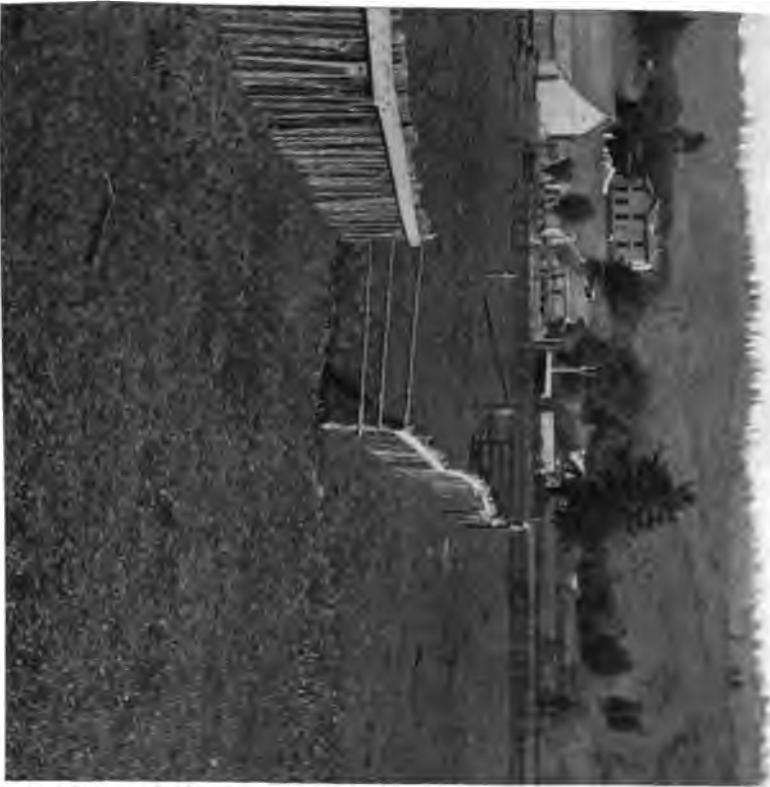
A. Fence offset by fault. Looking northwest. Camera was aimed with straight part of fence beyond the disturbance, to bring out flexure as well as offset of fence. G. K. G.

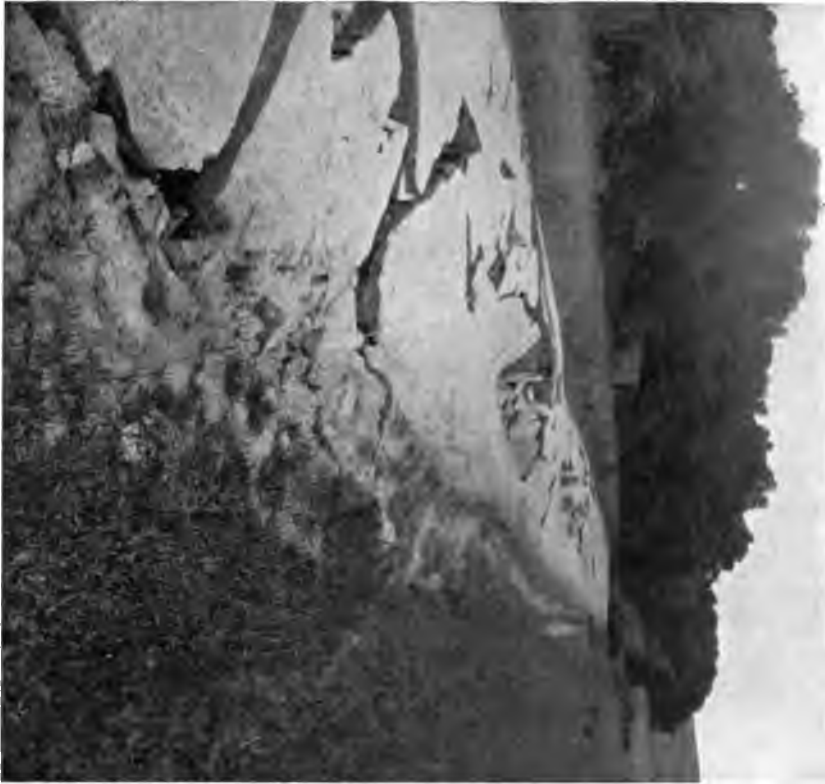
A. Road embankment broken by shaking of soft ground beneath. Southwest of Point Reyes Station and 10 rods from fault-trace. G. K. G.

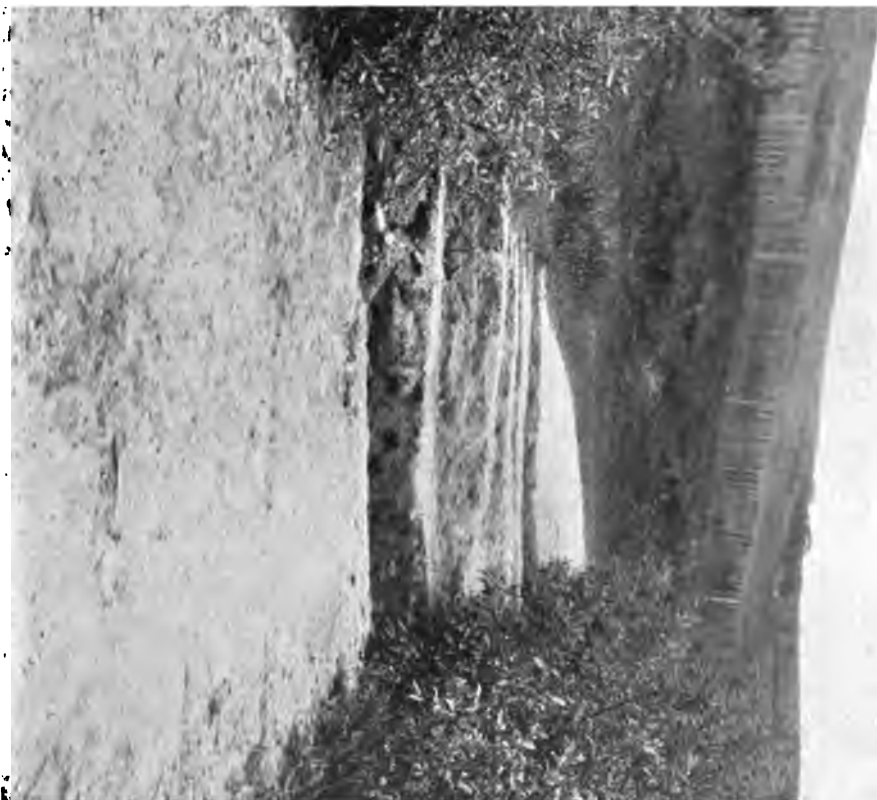
B. Faults in road embankment, southwest of Point Reyes Station. Fault-trace is beyond fence. Ground leveled toward marsh of Bear Valley Creek. G. K. G.

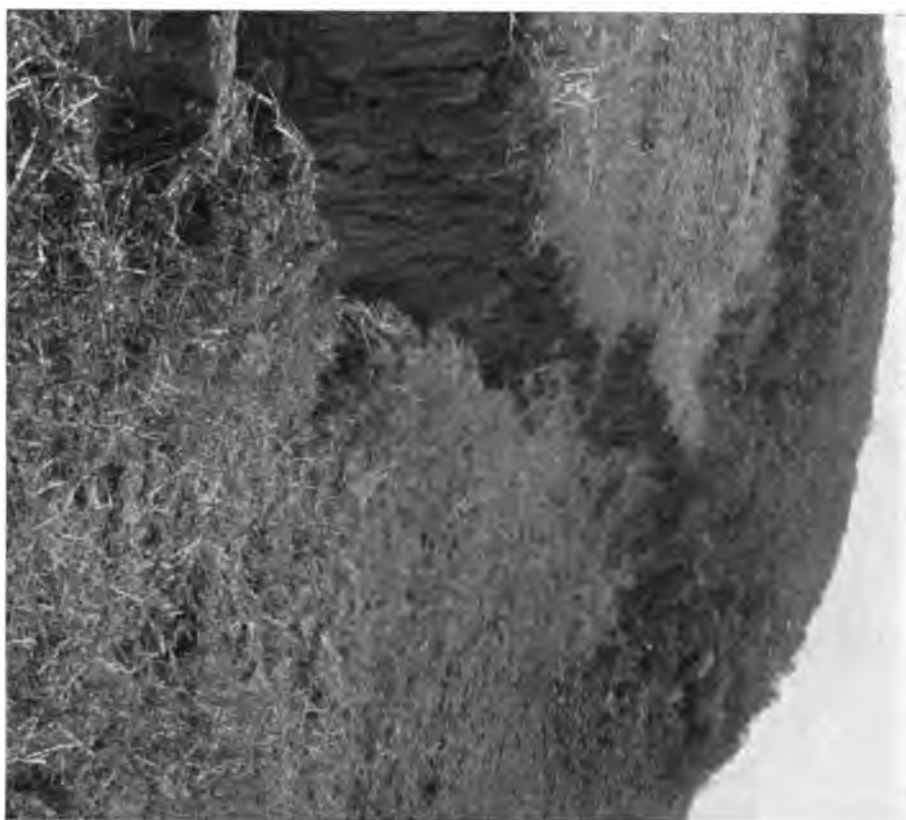
A. Fault-scarp on earthquake crack. Throw is about 5 feet. Compare Plate 52 A. G. K. G.

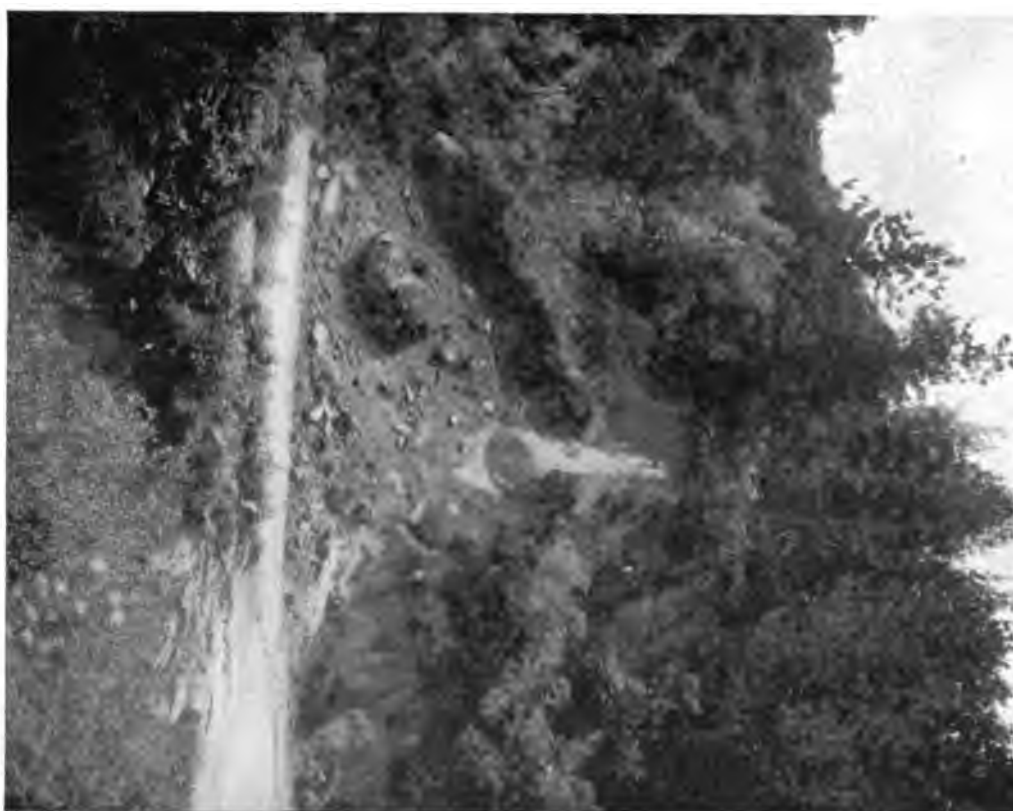
B. Landslide from road-cliff about two miles west of Inverness. Slide occurred at time of earthquake. G. K. G.

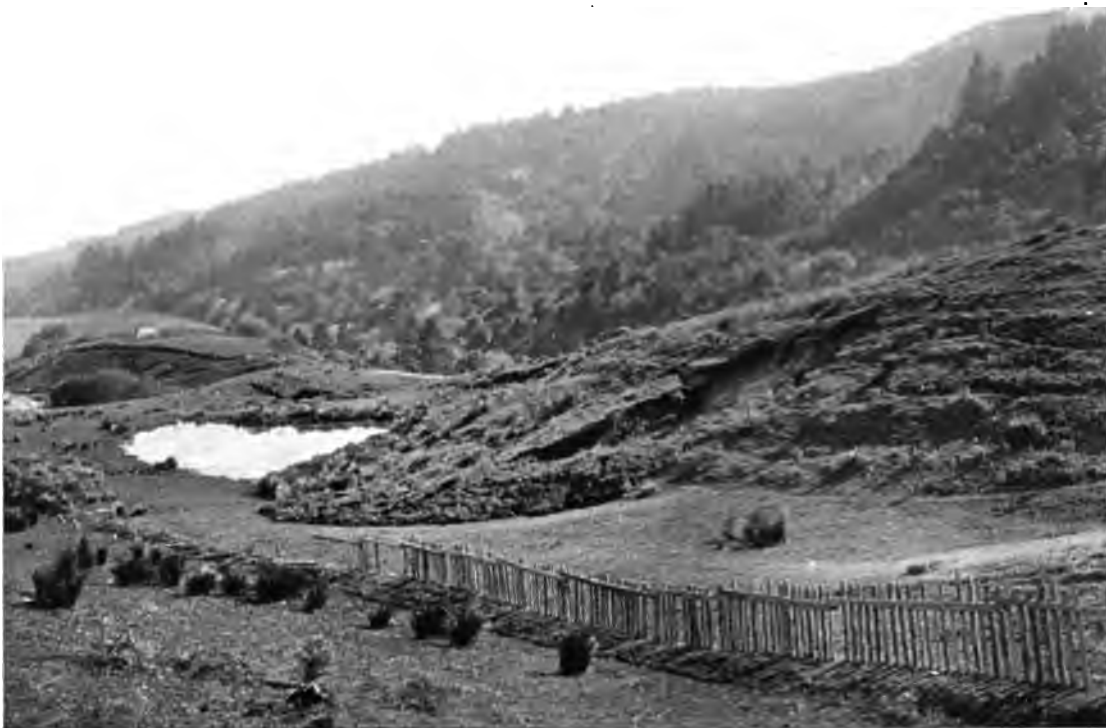
A. Landslide 4 miles northwest of Bolinas Lagoon. Looking south-southwest. Slide encroaches upon a rift pond, caused directly by rains early in 1907, indirectly by earthquake of 1906. G. K. G.

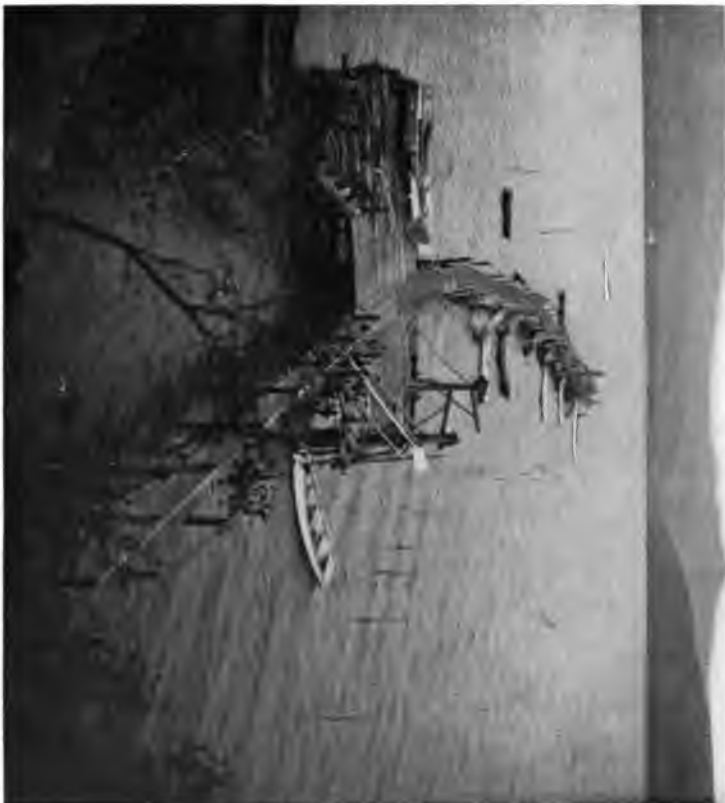
B. Bailey's pier at Inverness. Originally straight; shifted and much broken by earthquake. In subsequent repairs curvature caused by earthquake was retained. G. K. G.

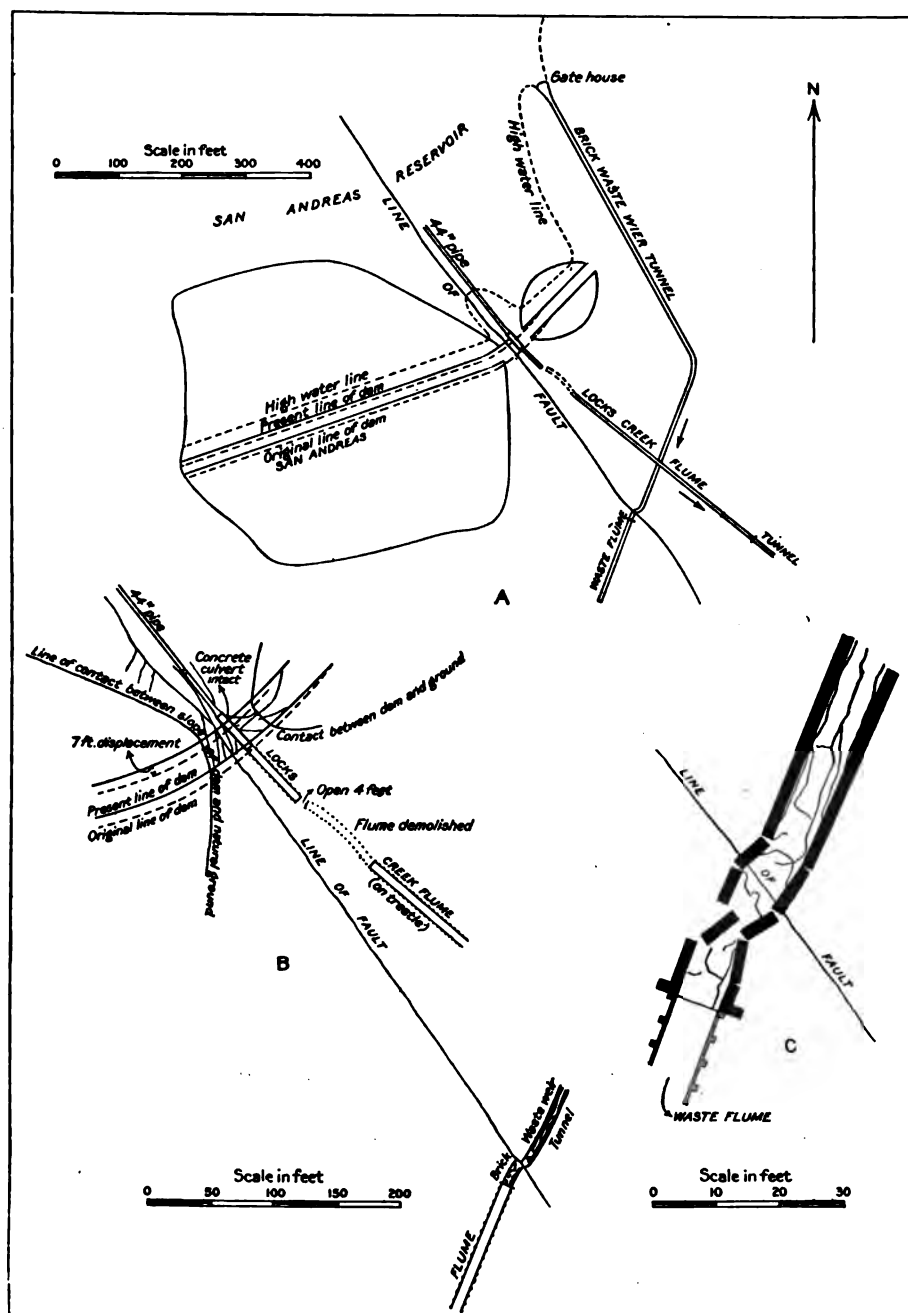
FIG. 36.—Intersection of San Andreas dam by fault. A. Plan of dam in two parts, with rock between. B. Relation of dam to waste weir tunnel. C. Detail of waste weir tunnel.

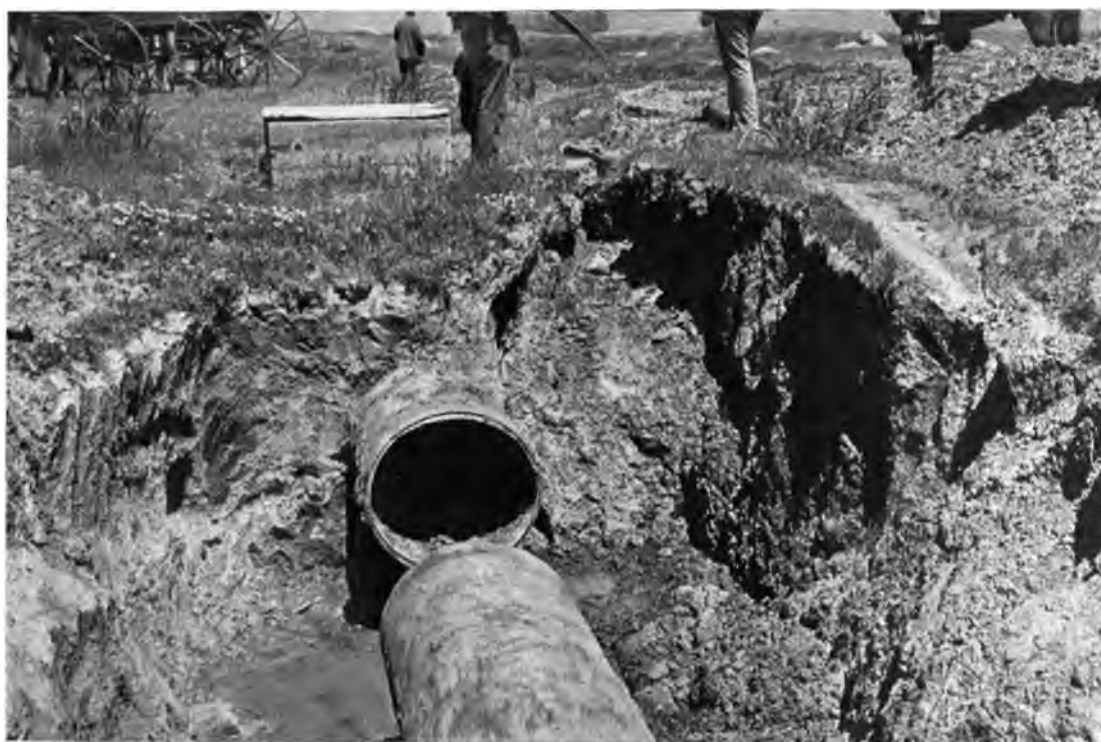
A. Rupture of 30-inch water-pipe by fault. Northwest of San Andreas Lake. A. C. L.

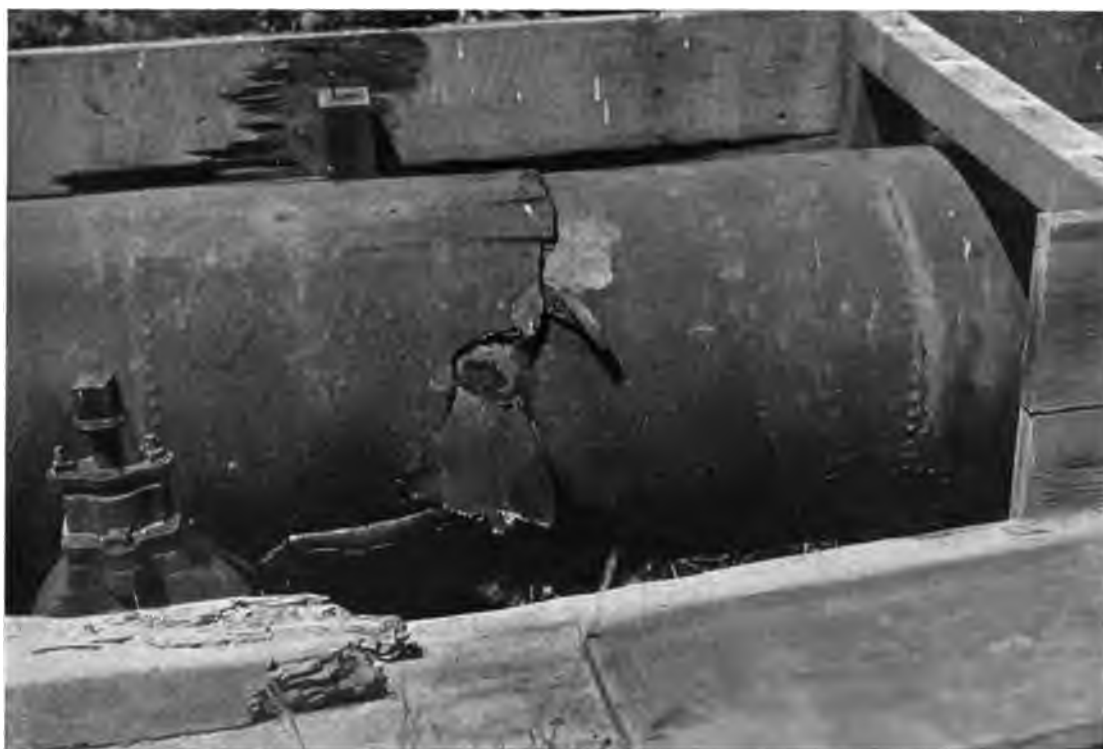
B. Thrust of 30-inch water-pipe by fault, northwest of San Andreas Lake. Amount of telescoping is 58 inches. A. C. L.

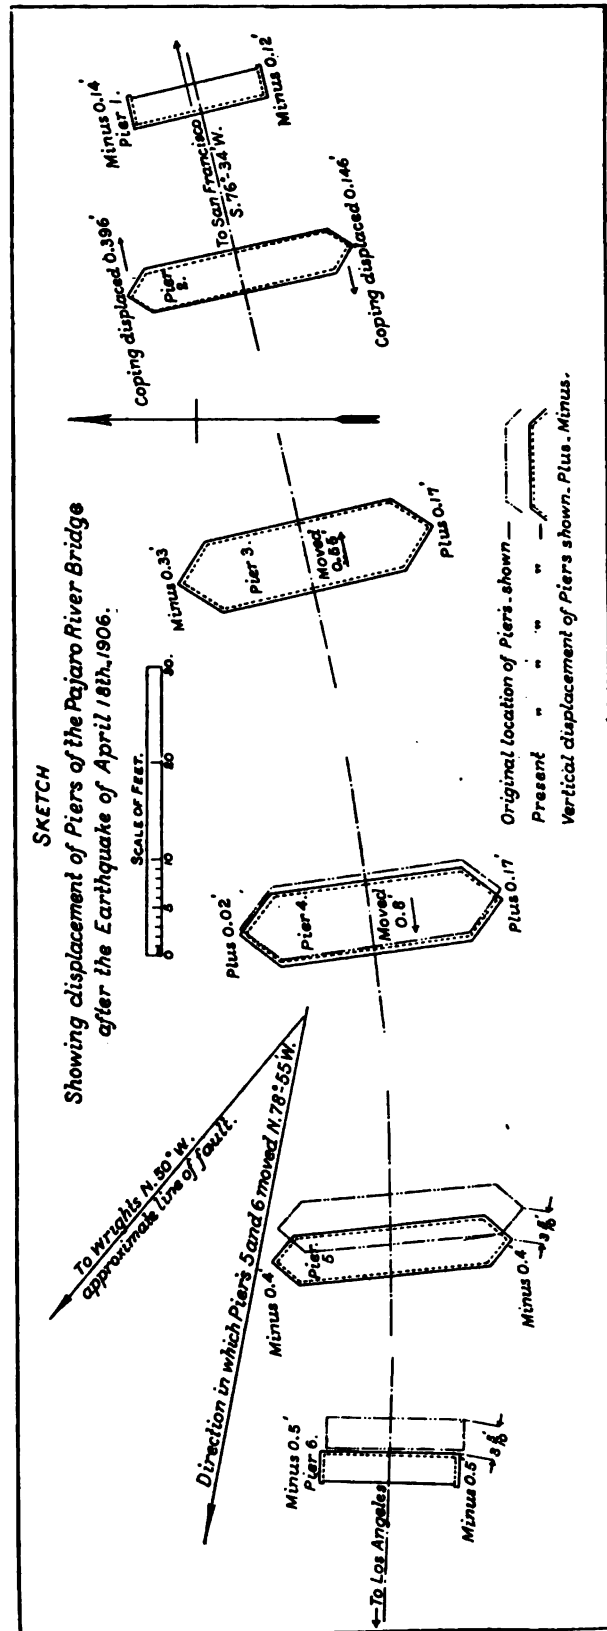
FIG. 43.—Displacement of piers of steel bridge at Chittenden.

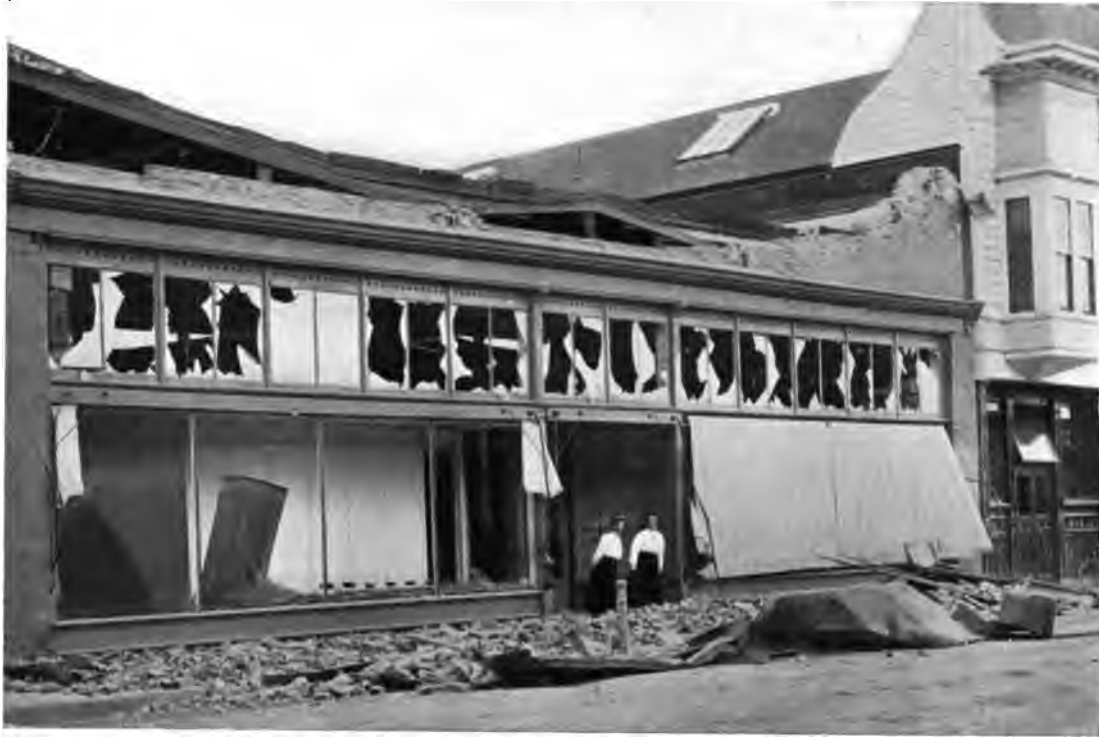
A. Wrecked stores. Ferndale, Humboldt County.

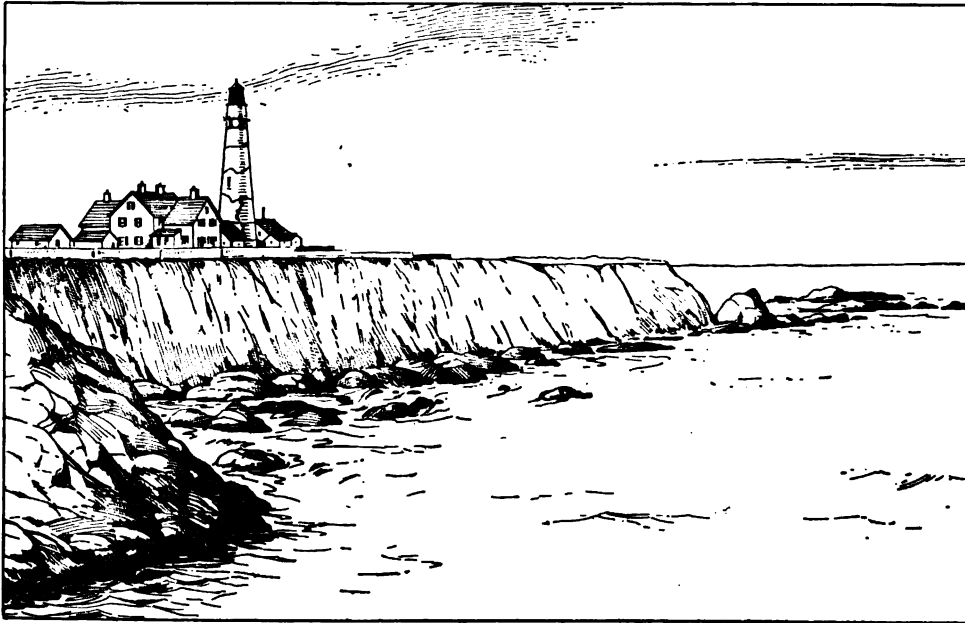
FIG. 49. — Cracks in light-house tower, Point Arena.

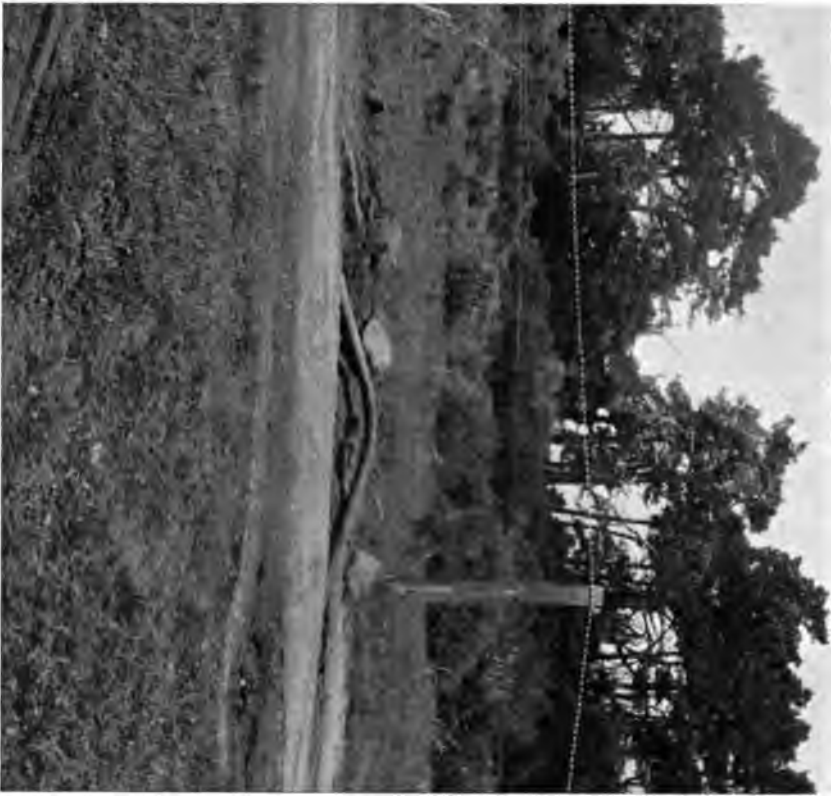
A. Buckled water-pipe, Inverness. G. K. G.

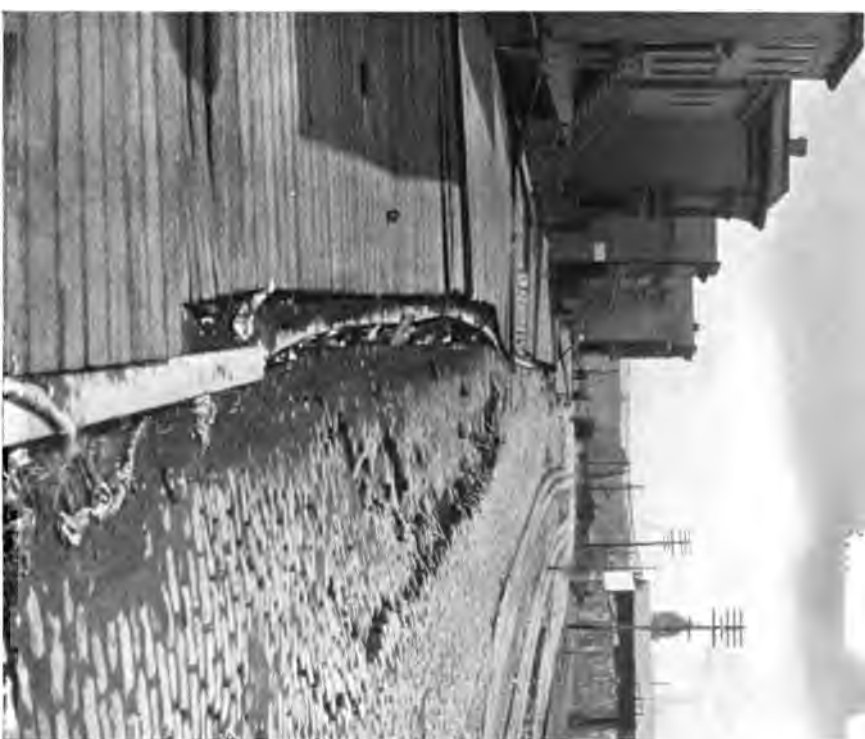
B. Ninth Street, between Bryant and Brannan. Westward lurching of land toward former creek channel where Dore Street now is. G. K. G.

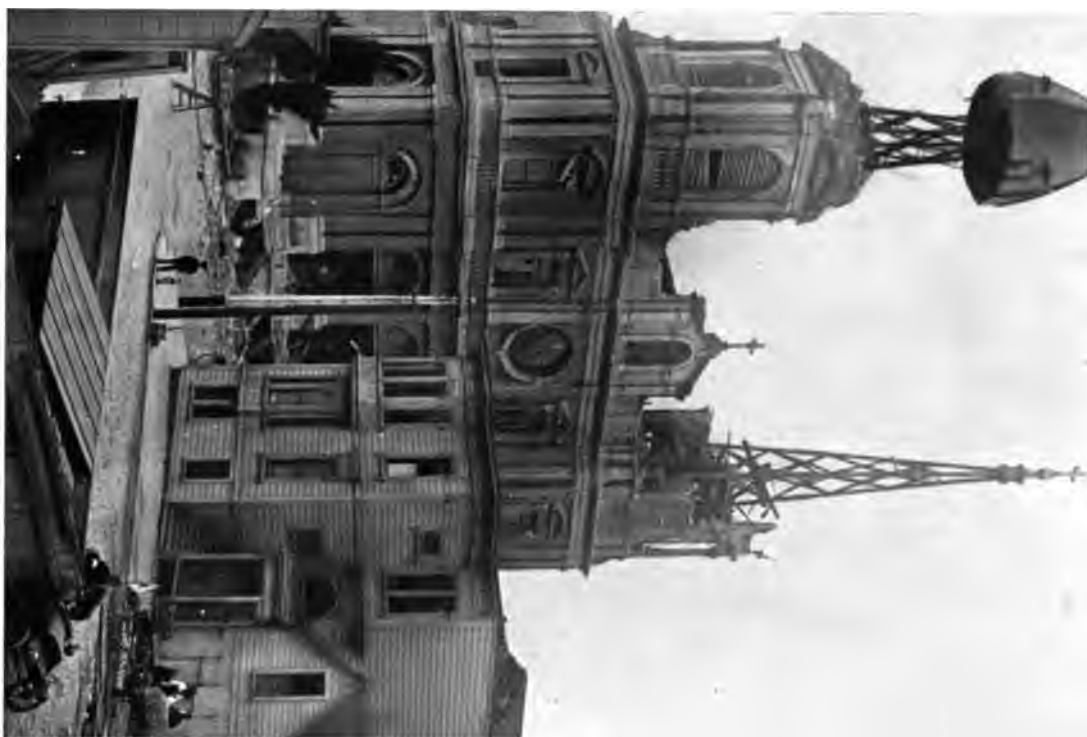
A. St. Dominic's Church, Bush and Steiner Streets. Brick and masonry structure upon sand and alluvium of no great depth. A. C. L.

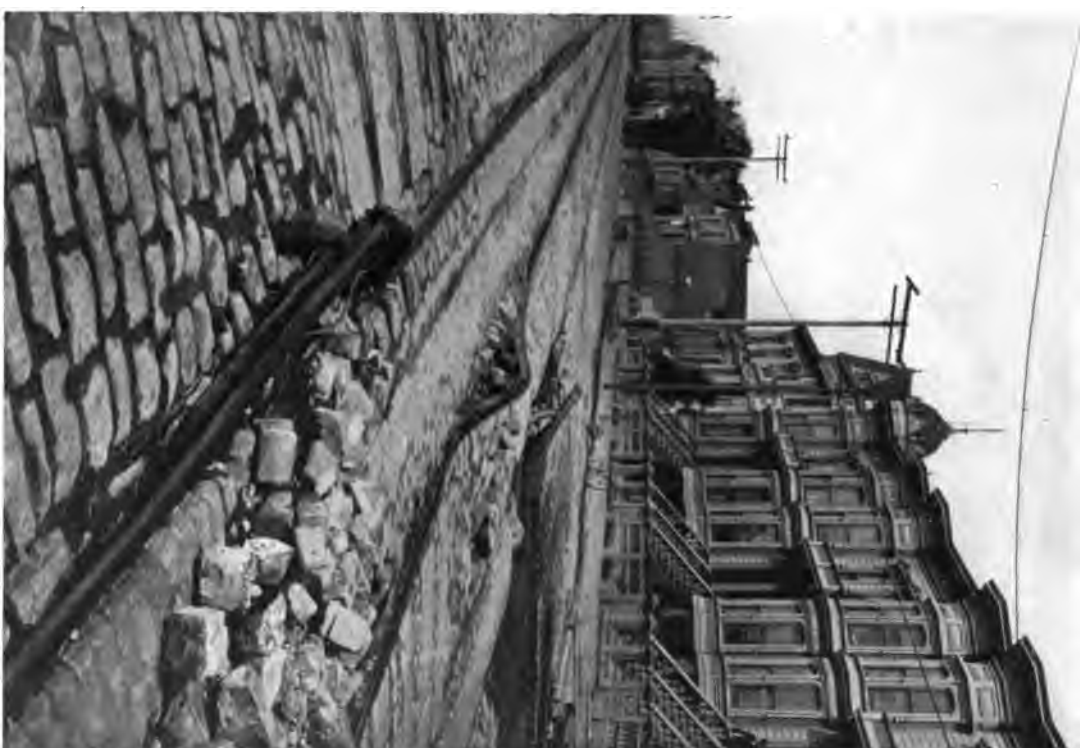
B. Looking south on Howard Street from near Seventeenth Street. Compression and flexure of car rails. G. K. G.

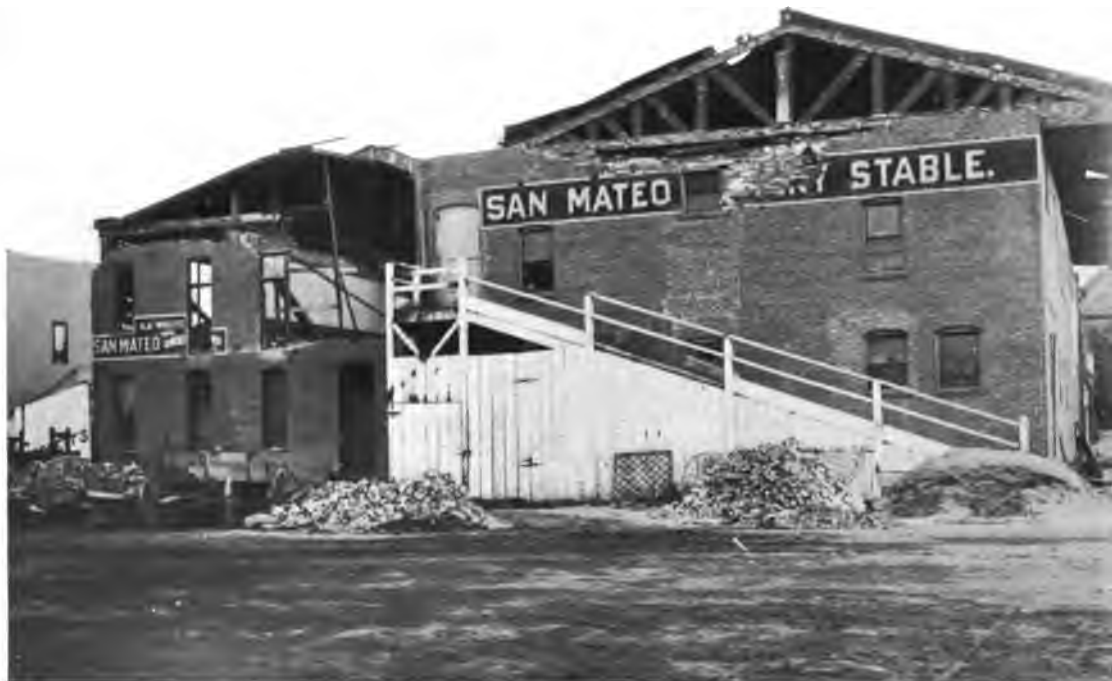
B. Brick stable, San Mateo. Upper story was thrown out and roof dropt one story. Per J. O. B.
